THOMAS LOWRY PARK:

2018 Conditions Assessment Report

1. PROJECT SUMMARY

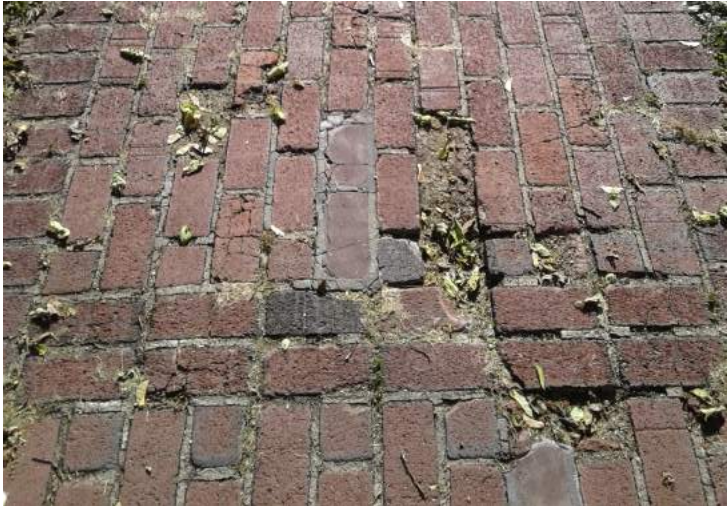
Missing bricks

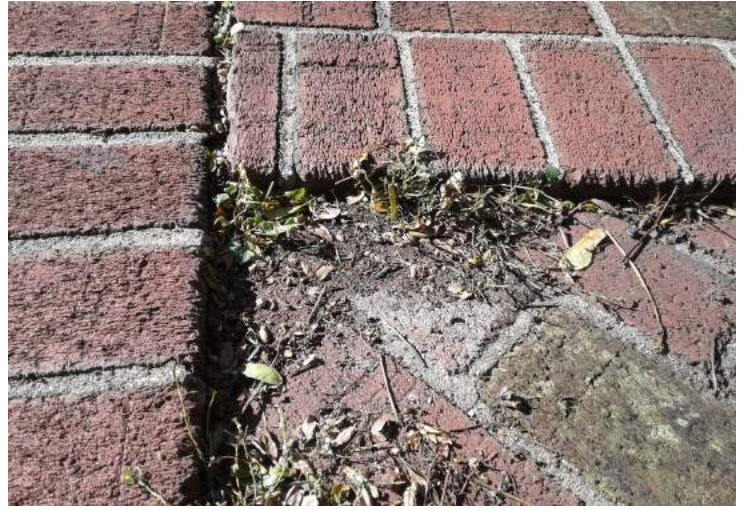
Uneven surface transitions

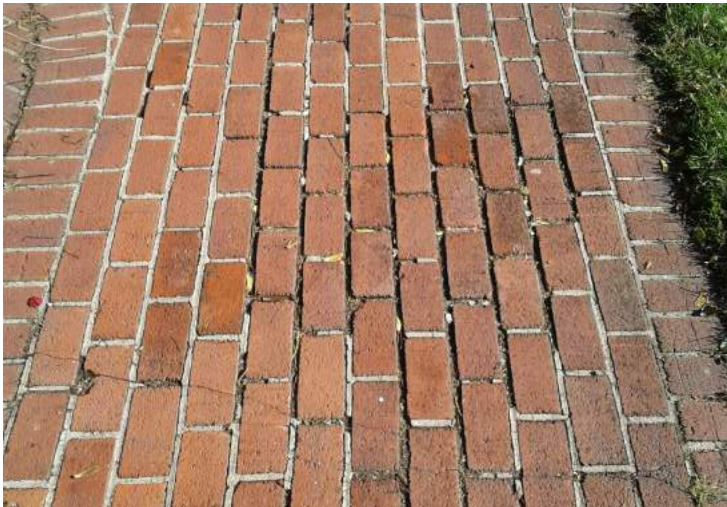
Fully deteriorated mortar joints

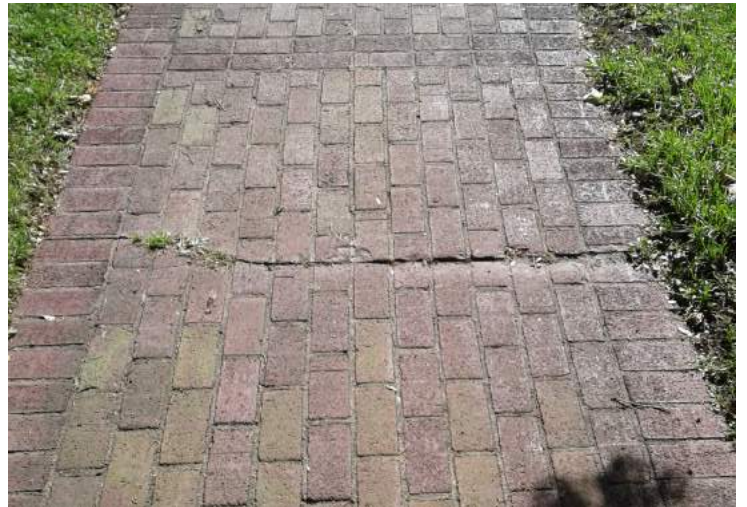
Different types of deterioration and damage were observed throughout the trail system. The appearance of shear cracking is likely due to differential settlement of the trail base. The existing paver system is constructed using a concrete base under mortar set pavers which does not have good longevity in this climate. The absorption of water into the system, combined with regular freeze/thaw cycles, causes differential movement of the paving resulting in erratic cracking.

Cracking likely due to significant shifts in paving base

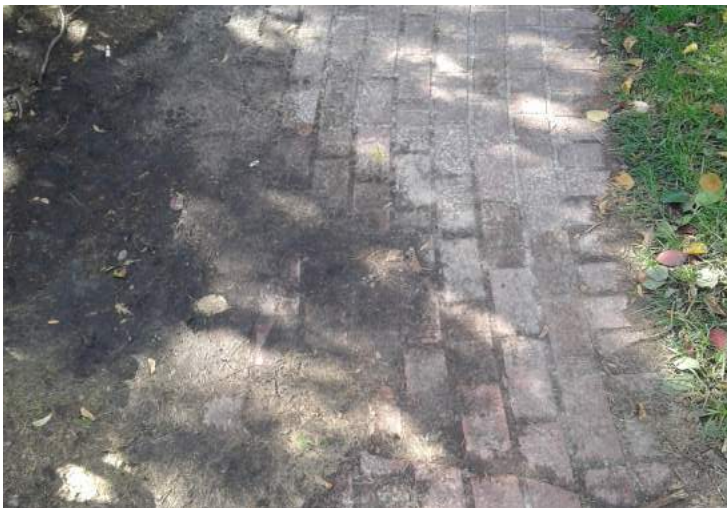
Sand/pooling due to drainage issues

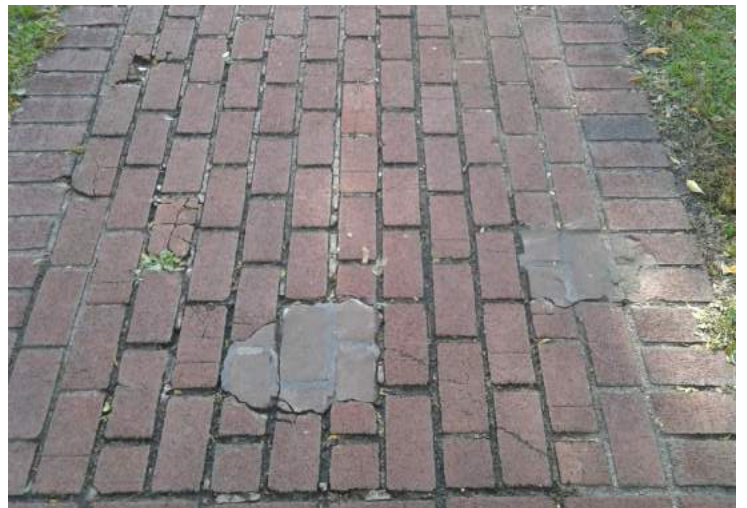
Mismatched patching

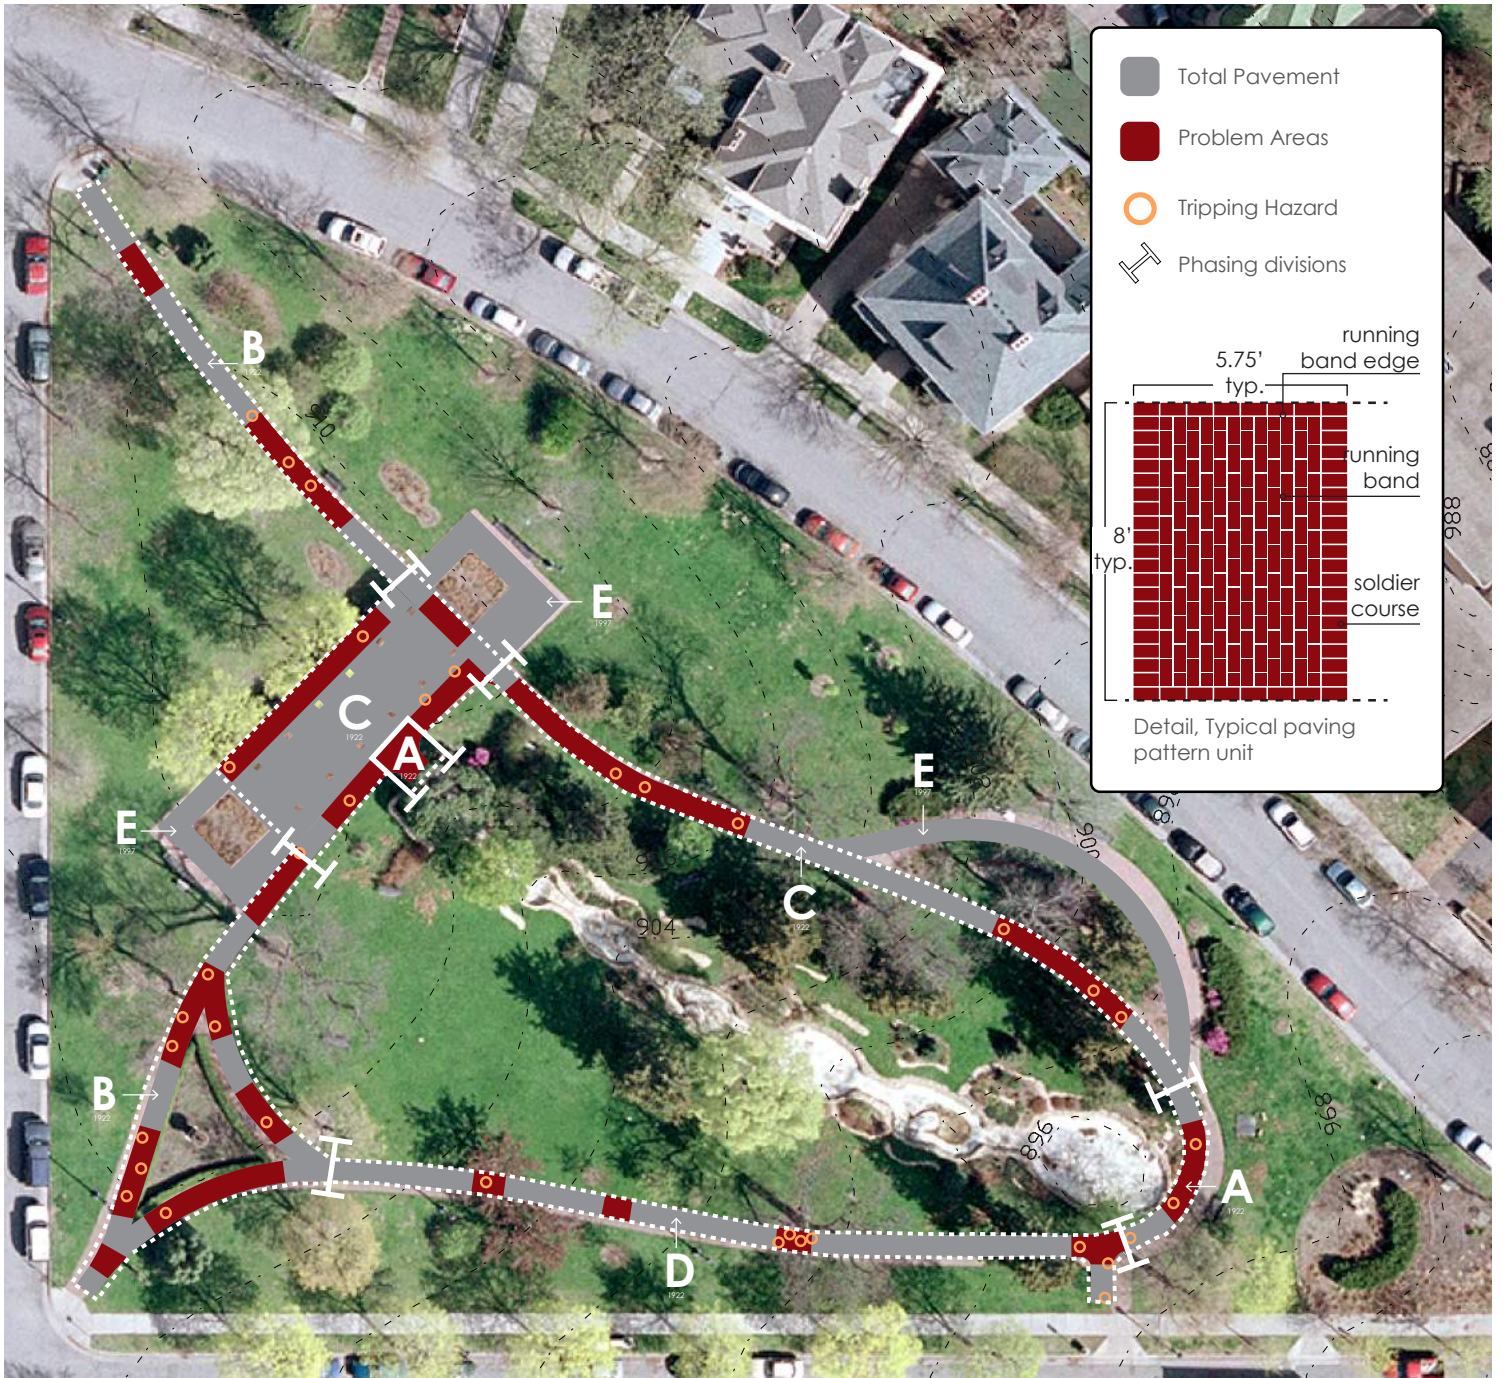
Problem Areas

Total paved area

9,580 sq. ft.

Significantly deteriorated area

3,150 sq. ft. → 33 % of total

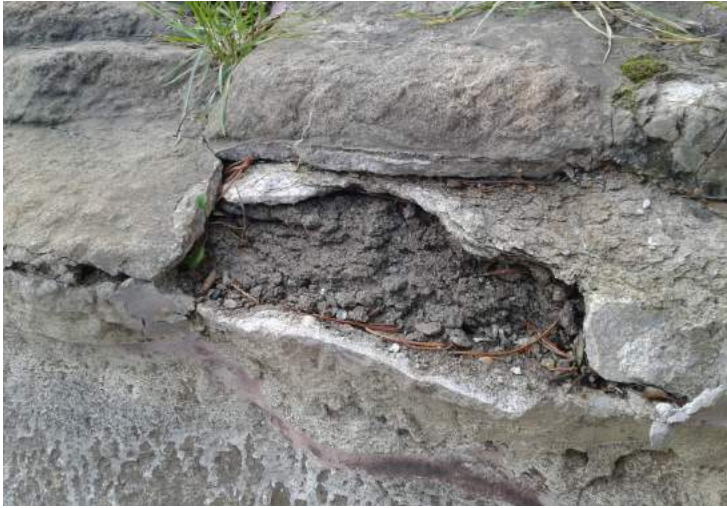
Missing sections

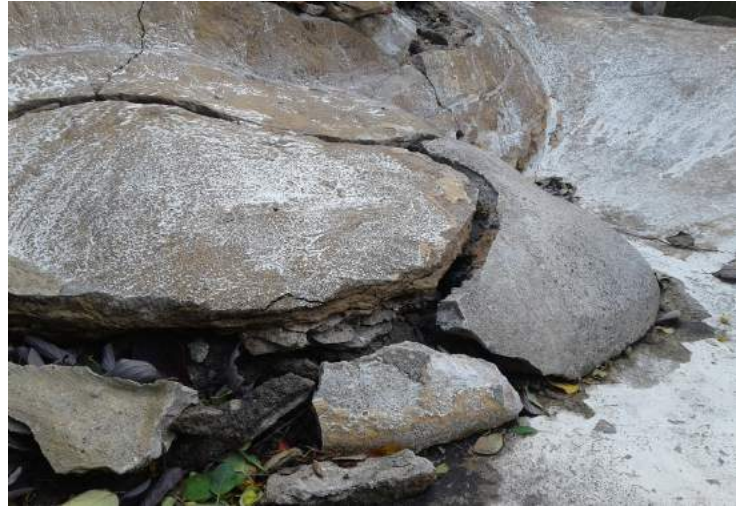
Extensive cracking and broken repairs

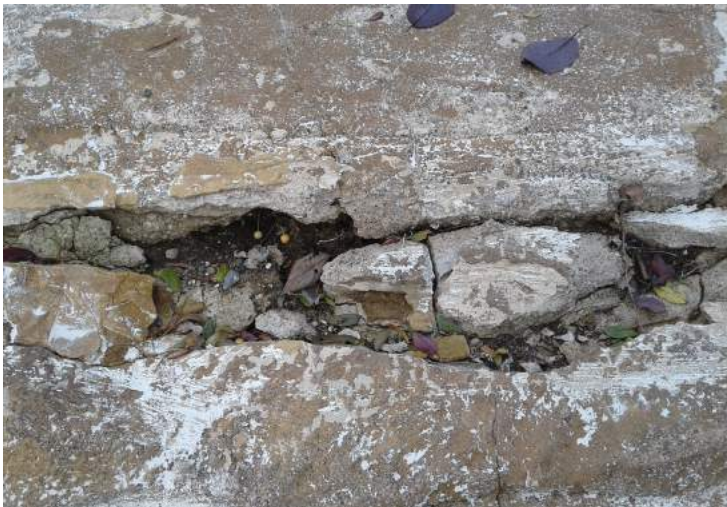
Fully deteriorated sections

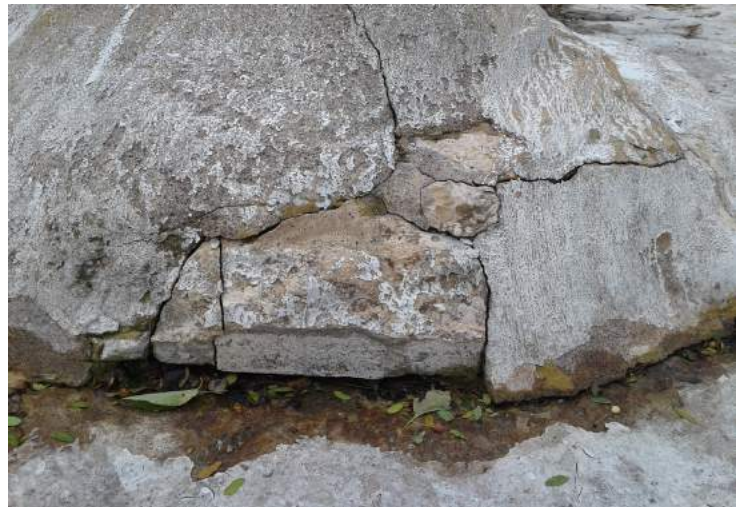
Cracking that suggests likely structural failure

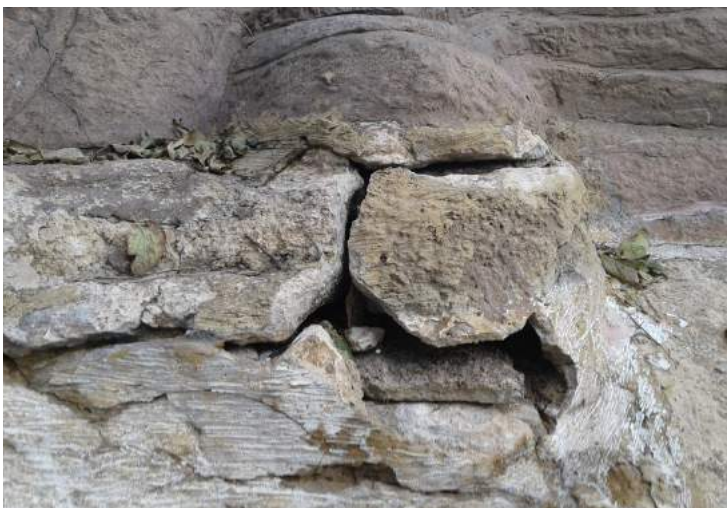
Sections likely to completely fail

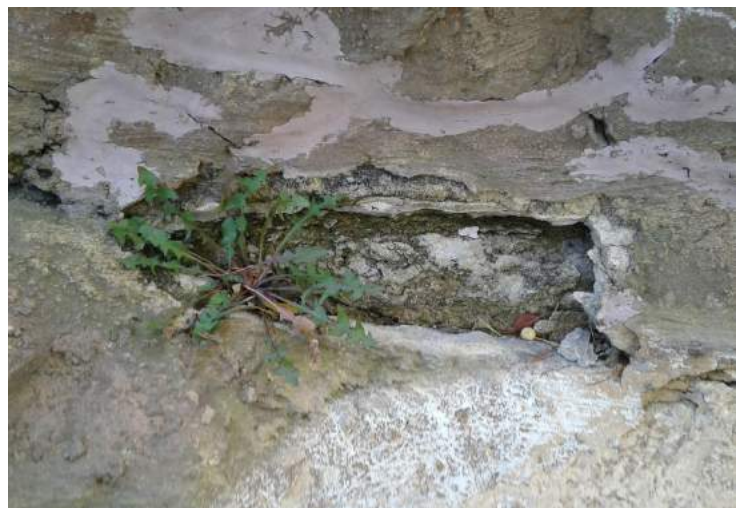
Mis-matched patching and sealing

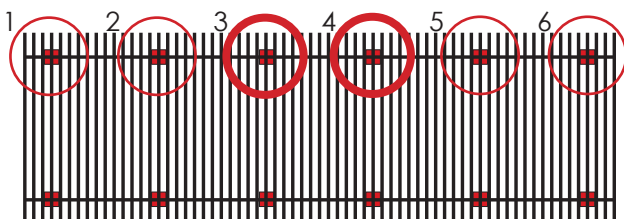
Detail, columns in need of some brick replacement

All mortar joints should be tuck-pointed. Six of the twelve columns have at least one visibly cracked brick, two of which are also in need of significant brickwork repair (columns 3 + 4). All of these columns are located on the NW side of the arbor. Here, the brick masonry should be removed and replaced with a selection of brick that directly matches the existing materials. More details are provided on page 17

We recommend engaging a contractor to fully tuck-point all arbor mortar joints, replace cracked bricks on columns 3 and 4, and align column caps as needed.

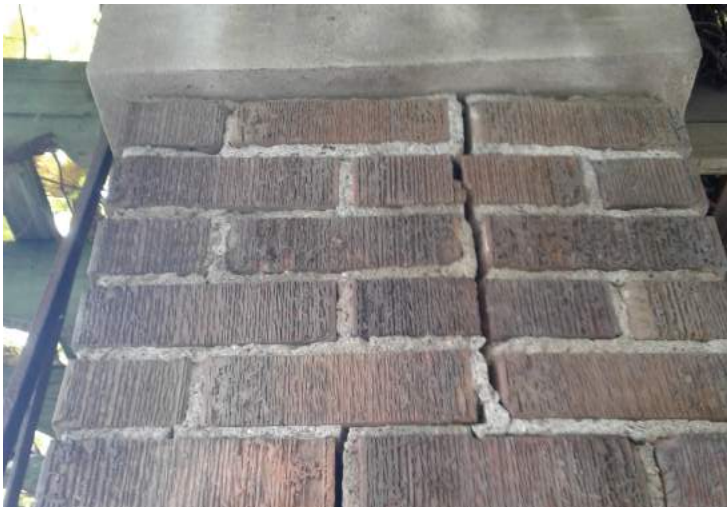
Extensive damage on column 4

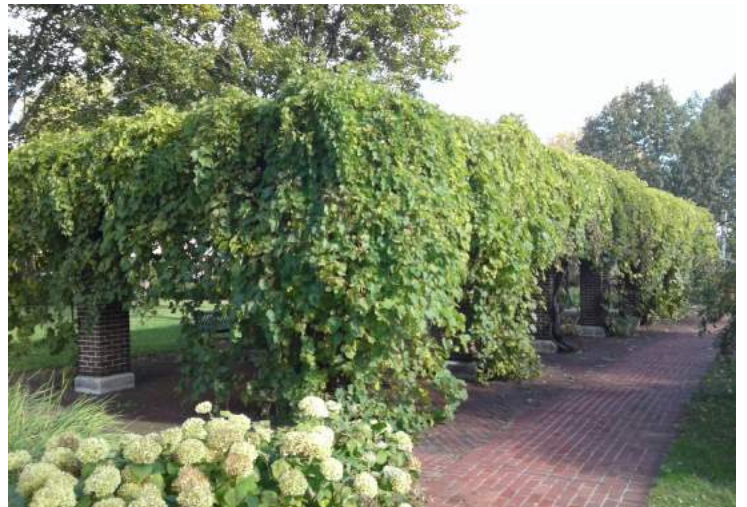
We recommend, as a first step, heavy pruning of the vines or full removal and replanting. The excessive weight of the vine and winter snow loads has likely led to the degradation of the mortar on the column brick masonry.

Overgrown vines

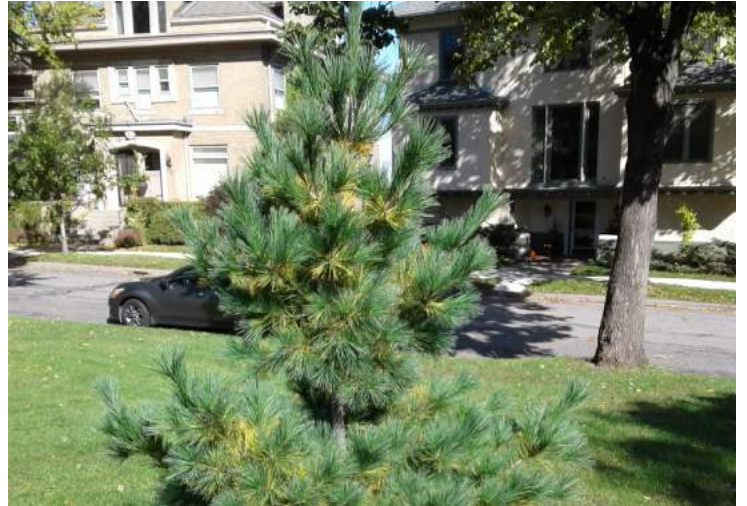
On-site vegetation is in good condition. Some of the recent tree plantings show signs of stress. These trees should be re-mulched, staked (if listing), and fertilized. Almost all mature trees are in good condition. Existing garden beds are well maintained but should be re-mulched and any spotty areas in-filled with new plantings. The grass is in good condition except for one small area in the southeast corner of the park where there are signs of erosion.

Stressed saplings

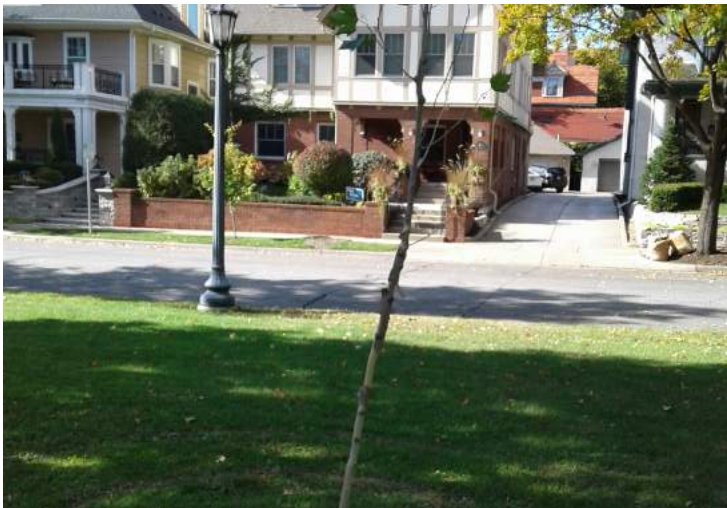
Stressed saplings

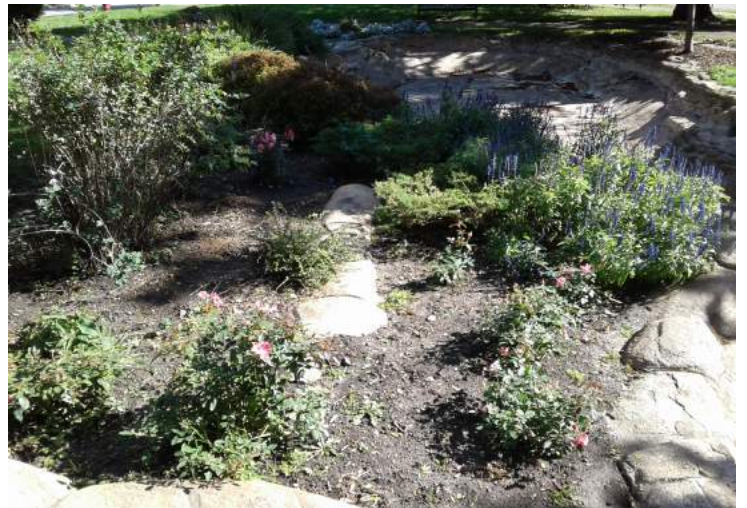
Patchy plant bed areas to be in-filled

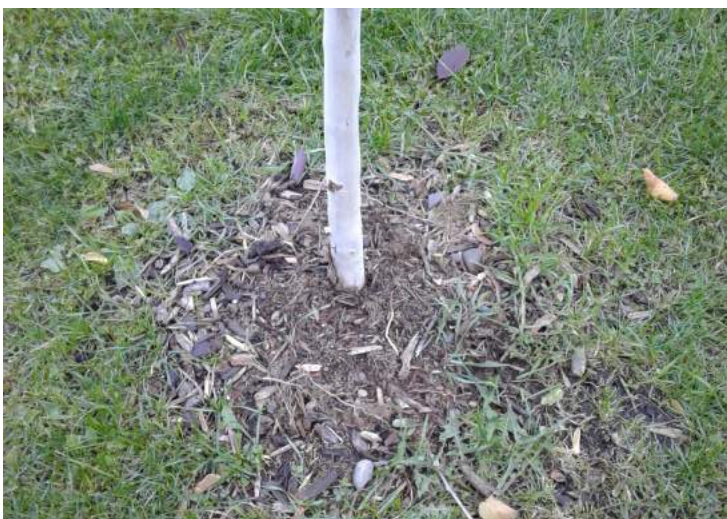
Areas to be re-mulched
