THOMAS LOWRY PARK:

2018 Conditions Assessment Report

1. PROJECT SUMMARY

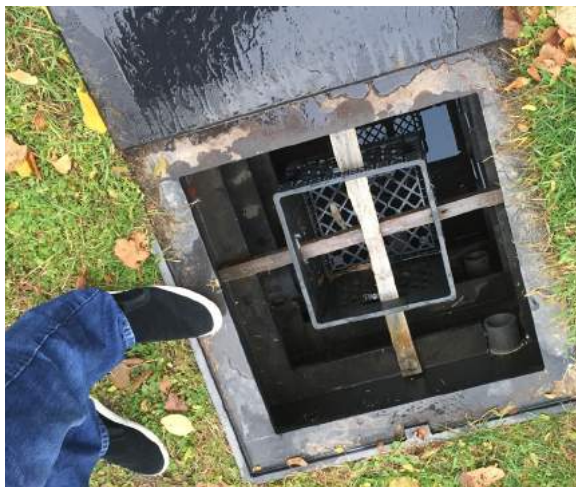
Fountain recirculation return
