THOMAS LOWRY PARK:

2018 Conditions Assessment Report

1. PROJECT SUMMARY

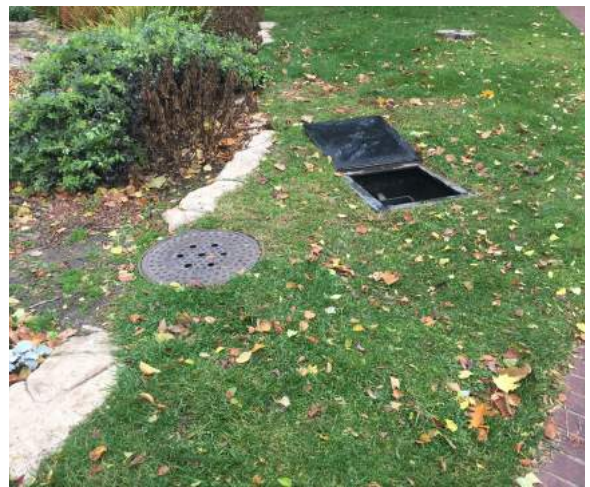
Utility covers

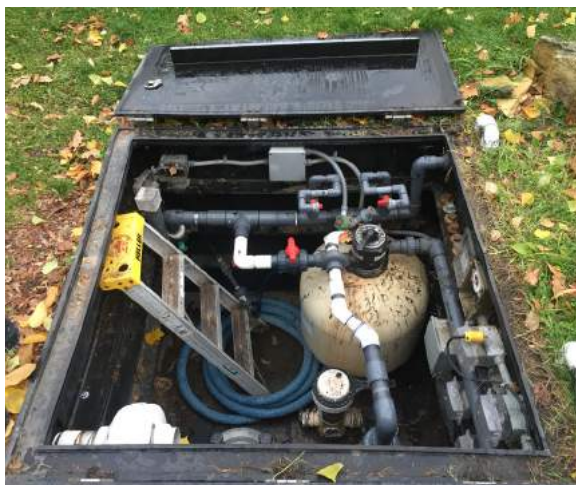
Equipment vault

Option 1: At a minimum, the existing pump equipment and controls within the underground vault could be replaced and new access doors installed to the vault.

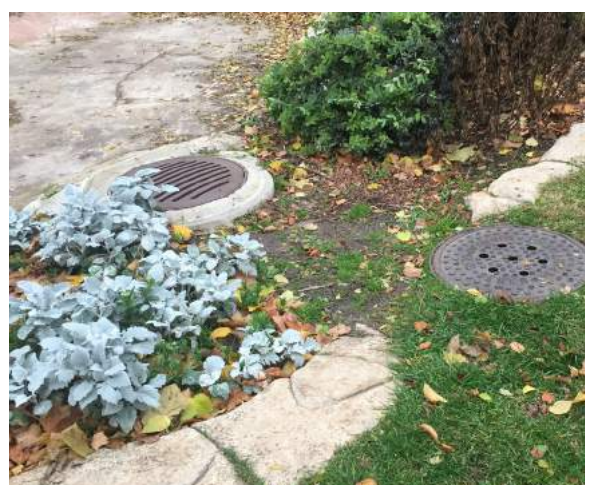
Utility covers

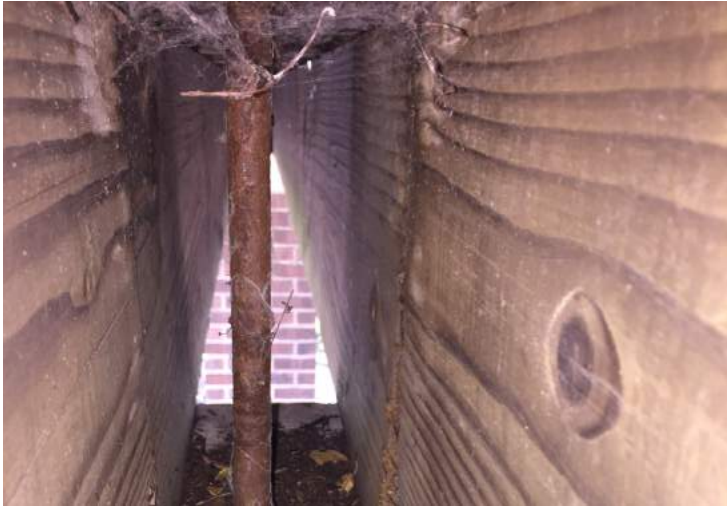
Anchor assembly

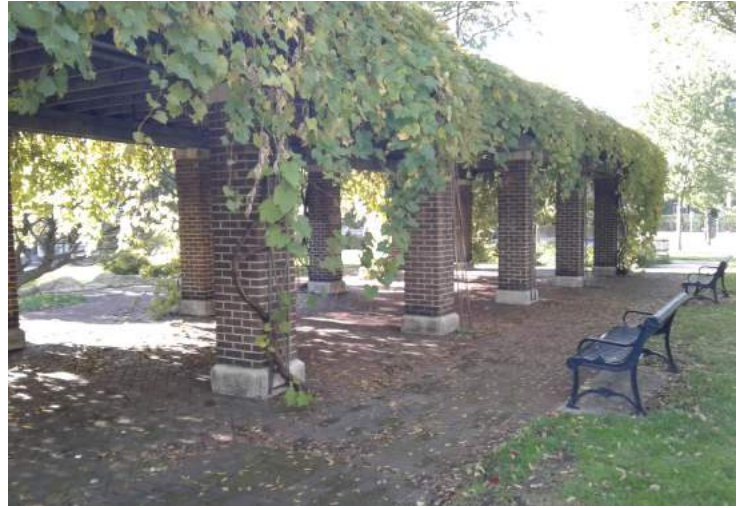
North side

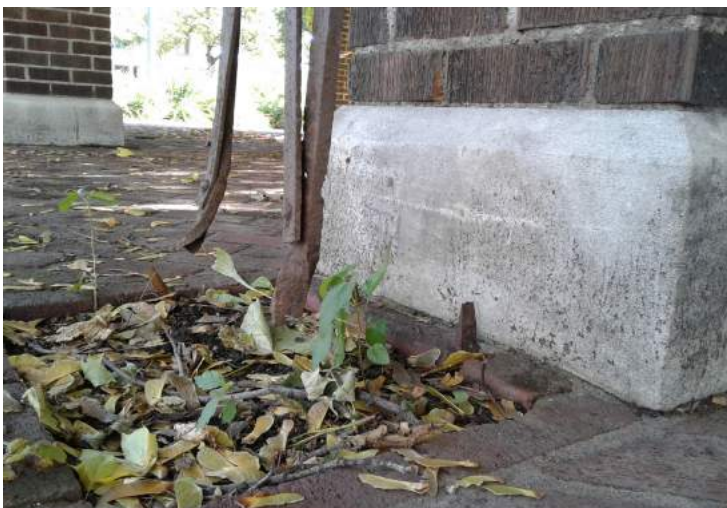
Trestle and planting beds

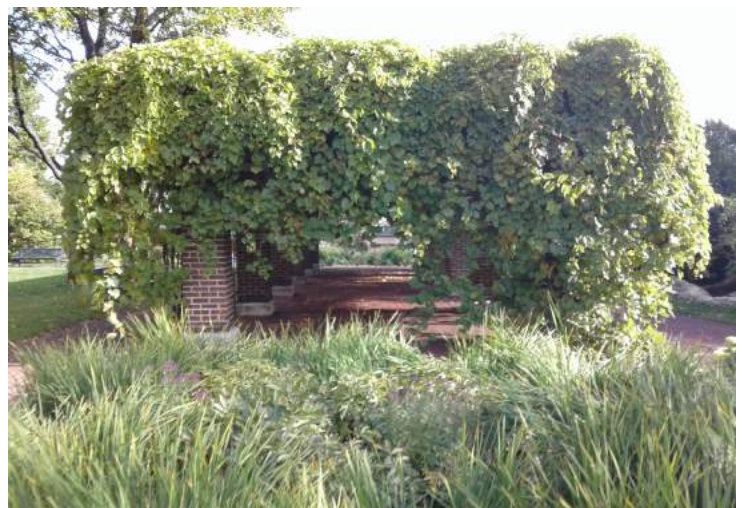
South side

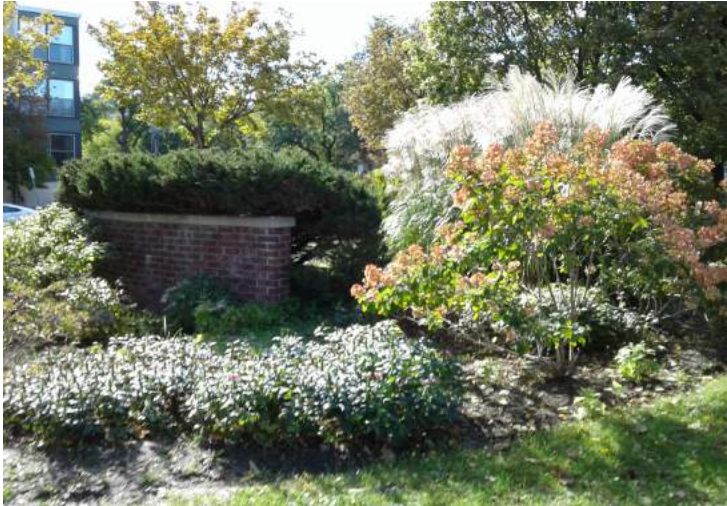
Entry sign plant beds

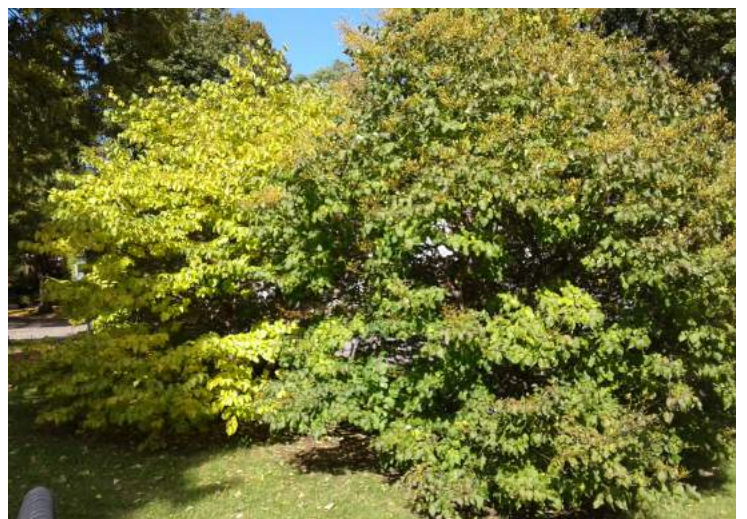
Typical bush condition

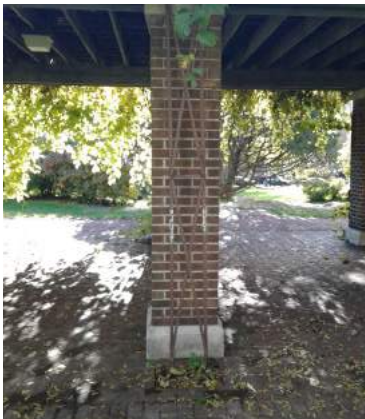
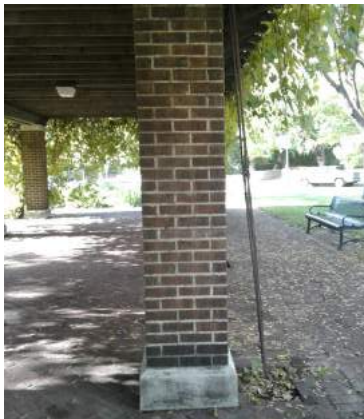
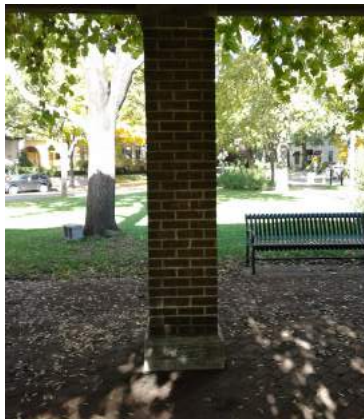
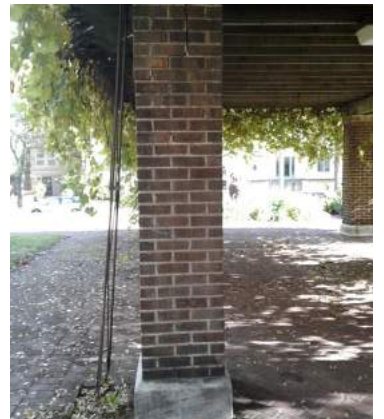
Extensive damage on column 4

We recommend engaging a contractor to fully tuck-point all arbor mortar joints, replace cracked bricks on columns 3 and 4, and align column caps as needed.
